Foam Domes

Spray Foam Solves Decades-Old Leakage Issues at Alaska Radar Site

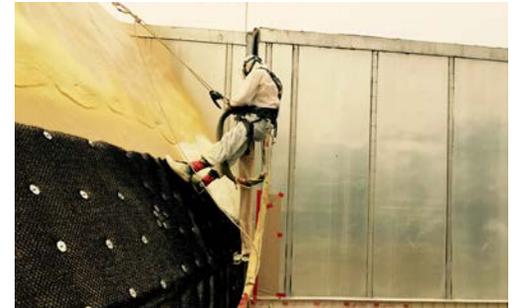
The numerous patch jobs previously used to seal the roof had created a questionable surface for the foam to adhere to. A monofilament mesh was used to give the foam a better surface to stick to, as well as eliminate the possibility of wind uplift.

The existing roof had many variations of coatings on it, so adhesion of the foam on the lower part of each building's dome was a concern. In order to prevent the foam from becoming delaminated at the bottom part of the domes, Polyseal mechanically fastened a woven monofilament, erosion-control mesh around the base of the

domes. This mesh gave a better surface for the foam to adhere to the substrate, and it prevented the foam from cracking. This is extremely important because the numerous patch jobs and previous fixes created a questionable surface for the foam to adhere to. The cost to remove the existing patchwork coatings would have increased the cost of the job exponentially. However, with the mesh in place, the foam could be applied right over the old patching material.

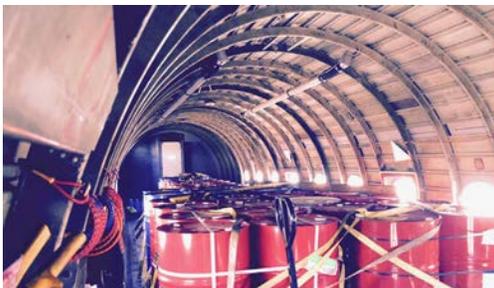
Due to the remote location of the jobsite, it took months of careful planning to make sure they got everything needed for the job, including 20% extra foam and enough spare parts to build a whole new spray reactor.

The biggest challenge of this project was logistics. There are no roads going to the LRRS, and the station is only accessible by plane. A gravel runway left over from the LRRS's days as an Air Force Base is the only place to land. It took several months of planning to account for everything Polyseal might need at the job site. They also brought in enough spare parts to build a whole new reactor machine, just to prepare for any contingency. This was

needed because it is next to impossible to get spare parts out in this remote location— if something happened, they couldn't just run to their local dealer and pick up a part. The mail only comes once a month, and to fly anything in costs \$6000 - \$8000. Time and cost would have been prohibitive otherwise.

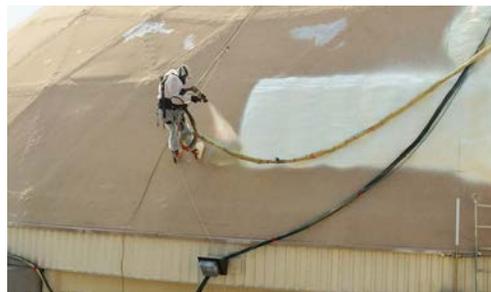
The polyurea coating was applied in two coats, with the base coat a different color than the top coat to ensure no spots were missed.

The applicators monitored and adjusted spray patterns to ensure that the foam was uniformly applied as a smooth surface. Creating a smooth surface is extremely important with roofing because it will allow for even distribution of the coating that would later go on top of it. That’s why, after the third lift, a very light pass of half an inch was done in order to have a nice surface for the Quik-Shield 952 polyurea hybrid roof coating to stick to.
